LONG-TERM IMPACTS OF THE 1997 FLOODS IN THE MORAVA RIVER BASIN

A. Vaishar, P. Hlavinková, K. Kirchner, J. Lacina: *Long-Term Impacts of the 1997 Floods in the Morava River Basin*. Geografie – Sborník ČGS, 105, 2, pp. 141 – 154 (2000). In 1997 disastrous floods, unparalleled since meteorological and climatic measurements have been carried out, took place in the catchment of the Morava river and other Moravian rivers. The long-term impacts of the above-mentioned flood event on the landscape and society have been examined in four selected model areas with different natural and economic characteristics. Within the natural system, the long-term impacts include changes in riverbeds, landslides and changes in the biota. Within the social system, the most significant adverse impacts include the long-term damage to the psychical health of those affected by the flood. The main causes of the flood damage are connected with the formation of the settlement pattern during the period of industrialisation and urbanisation. The main methods of flood protection include the relocation of structures outside inundated areas, technical control and the adaptation to flood risks.

KEY WORDS: natural risk

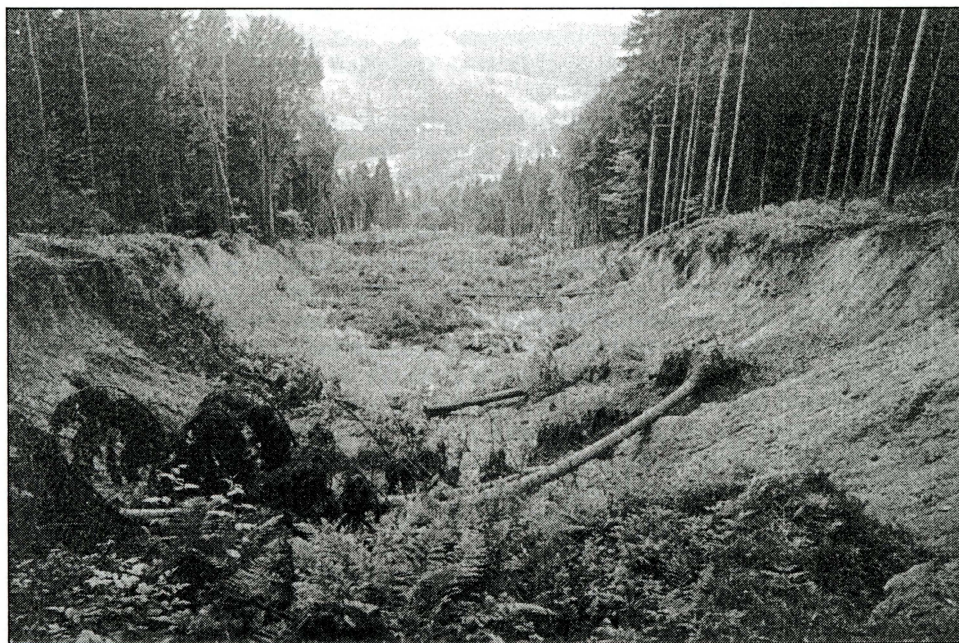
Fig. 3 – Example of a landslide in the cadaster of the Bystřička village (photo by K. Kirchner)

A great amount of slope processes (particularly landslides and ground streams) was activated in the area formed by the flysch complexes in the Outer Western Carpathians (the mountainous part of the catchment of the Bečva river) where the geological conditions for the development of slope deformations are very favourable. In the district of Vsetín, the activity of the slope deformations locally reached almost disastrous effects (Kirchner, Krejčí, 1998). In the catchment of the Rožnovská Bečva river, a series of landslides was activated by the lateral erosion of watercourses. Smaller watercourses were frequently under the threat of their streambeds being dammed up (e.g., the Solanecký potok /Solanecký brook/). South of Rožnov p. R., the lateral erosion caused the movement of a landslide of a length of up to 20 m collided into the streambed of the Rožnovská Bečva river (Kirchner, Krejčí, 1998a). Extensive ground streams and landslides affected the valley slopes of the Bystřička water reservoir, bringing a great amount of fine-grain material into the reservoir. This material accumulated together with the flood sediments. A series of hazardous landslides has already been cleared, however the majority of slope deformations could be reactivated under favourable conditions and their activity is long-term.

Obr. 3 – Příklad sesuvu v katastru obce Bystřička (snímek K. Kirchner)

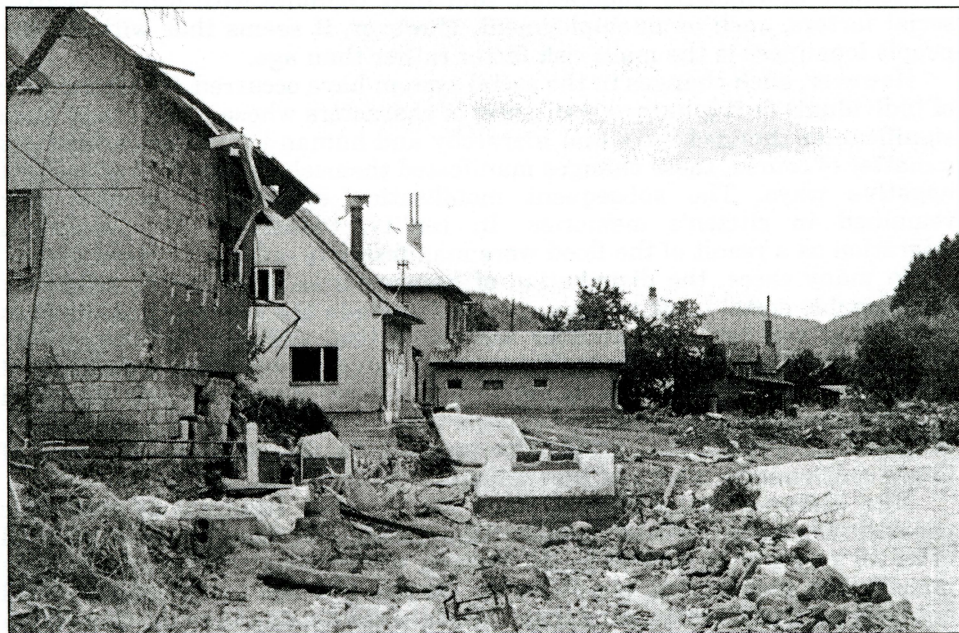
Fig. 4 – Structures damaged by the flood in the village of Bystřička (Photo by K. Kirchner)

Obr. 4 – Povodní poškozené objekty v obci Bystřička (snímek K. Kirchner)
