FLOODS 2002 IN PRAGUE – REFLECTIONS, LESSONS AND IDEAS

R. Baena, B. García, I. Guerrero, F. Hartvich, B. Leicht, L. Marchiol et al.: *Floods 2002 in Prague – reflections, lessons and ideas*. – Geografie – Sborník ČGS, 109, 2, pp. 170–180 (2004). – This contribution deals with the consequences of floods, which affected the capital of CR, Prague, in August 2002. The members of working group have seen the situation one year after the event. The article is divided into three parts, each dealing with specific area of problems. First part concerns the measures that should be taken before the flood event occurs, including long-term flood protection strategy. In the second part we discuss the succession of steps to be performed in order to minimize the endangerment of public and the damages during the flood period. Last section suggests solutions and lessons that might be taken from the 2002 flood event's course and its consequences in Prague.

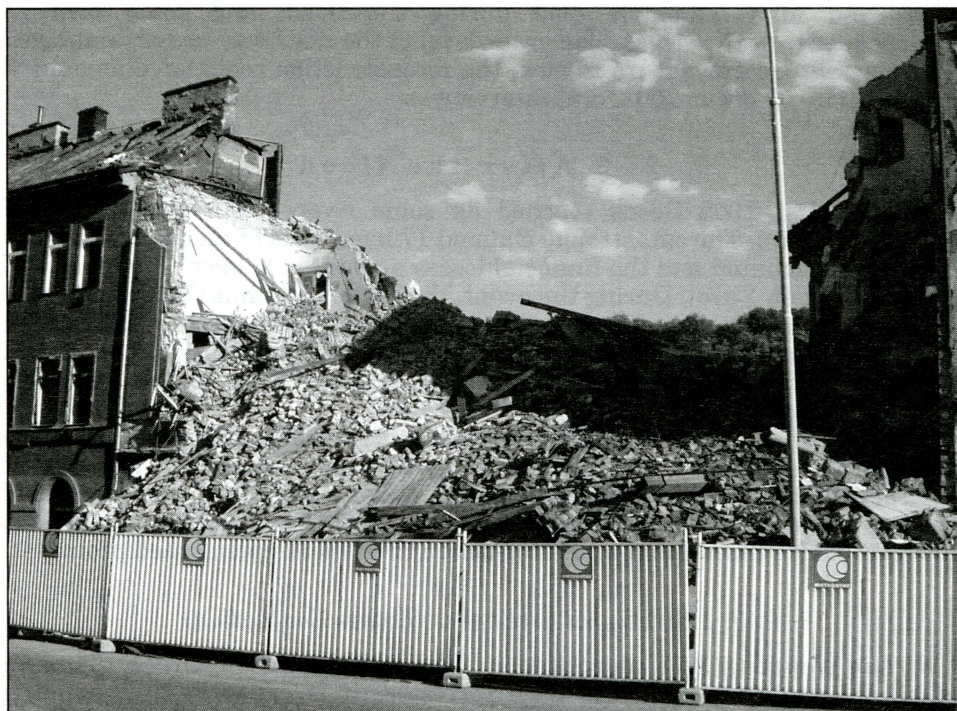
Fig. 2 – Collapsed building in Karlín (summer 2002)

Prague 2003) and to build up an additional. In August 2002 the construction work was at a more or less initial state. As the complete area was seriously affected by the flood (see fig. 2), it was feared that investments could be withdrawn.

Obr. 2 – Zřícený dům v Karlíně (léto 2002)
