BOHUMÍR JANSKÝ, ACHIM SCHULTE, JULIUS ČESÁK,
VANESSA RIOS ESCOBAR

THE MLADOTICE LAKE, WESTERN CZECHIA: THE UNIQUE GENESIS AND EVOLUTION OF THE LAKE BASIN

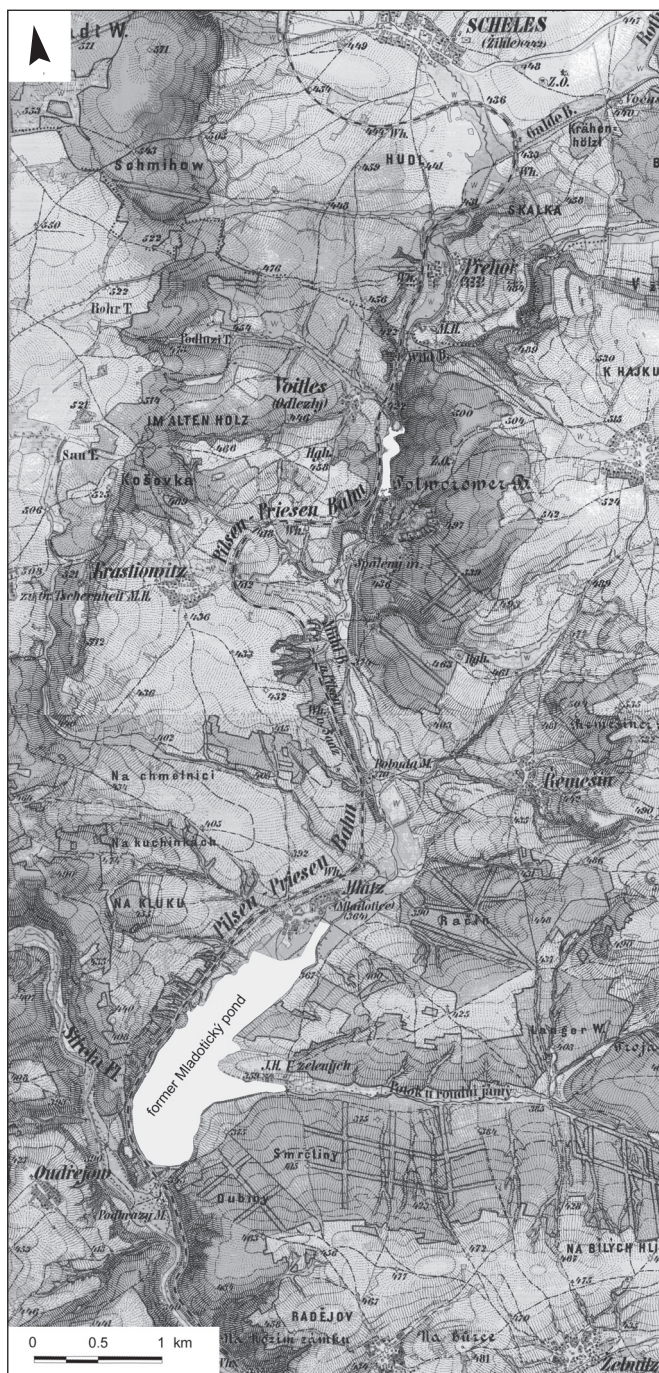
Fig. 2 – The map of the Third Military Mapping of Austrian Monarchy from 1890. The map illustrates the newly originated Mladotice Lake and the former Mladotický Fishpond, which was located at the southern edge of Mladotice Municipality.

In connection with the extraordinary intensity of precipitation, two natural catastrophes occurred in the valley of the Mladotický stream (the left tributary of the Střela River, Fig. 1). During the night from 27 to 28 May, large masses of arkose and conglomerate from the western slope of the Potvorovský Hill (546 m) slid down into the Mladotický stream's valley, damming the stream with a massive dike (Figures 4 and 5). The resulting lake is, to this day, the only example of such a genetic type of lake in the Bohemian Massif. The second disastrous event was the rupture of the Mladotický Fishpond dam, which was located at the southern edge of Mladotice Municipality. With an area of roughly 92 ha it was, at that time, the largest fishpond in western Bohemia. After its destruction, the pond was never restored (see the map in Fig. 2).

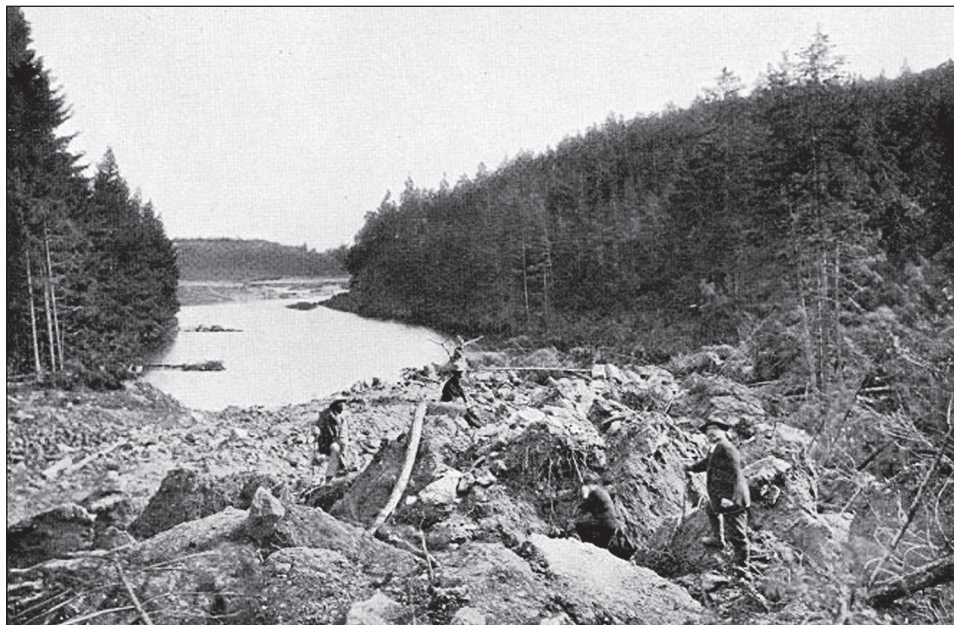
Fig. 4 – Dammed valley immediately after the landslide in May 1872, the lake is emerging in the background. Print from the *Geografie (Sborník ČSZ)* 28, Praha 1912. Photo by C. Purkyně.

4. The intense rainfall at the end of May 1872 played a decisive role in the final phase of the landslide. The slope had already been sufficiently disrupted with numerous fissures, cracks, quarries and even the cutting of a railway track. The water easily penetrated the disrupted upper layers and proceeded to thoroughly saturate the coarse-grained and porous arkose, sandstone and conglomerate. This substantially increased the weight of the upper layers and even altered other physical characteristics of the mass of sandstone minerals (its rigidity and the tension of the minerals). After being saturated with water, the clay cement softened and the shale in the bedrock also became wet. Friction was reduced and masses of upper-layer minerals began to slide down into the stream valley. This movement took place over the space of two days, 27 and 28 May 1872. The landslide dammed the valley for a length of 300 m (Figs. 4 and 5).

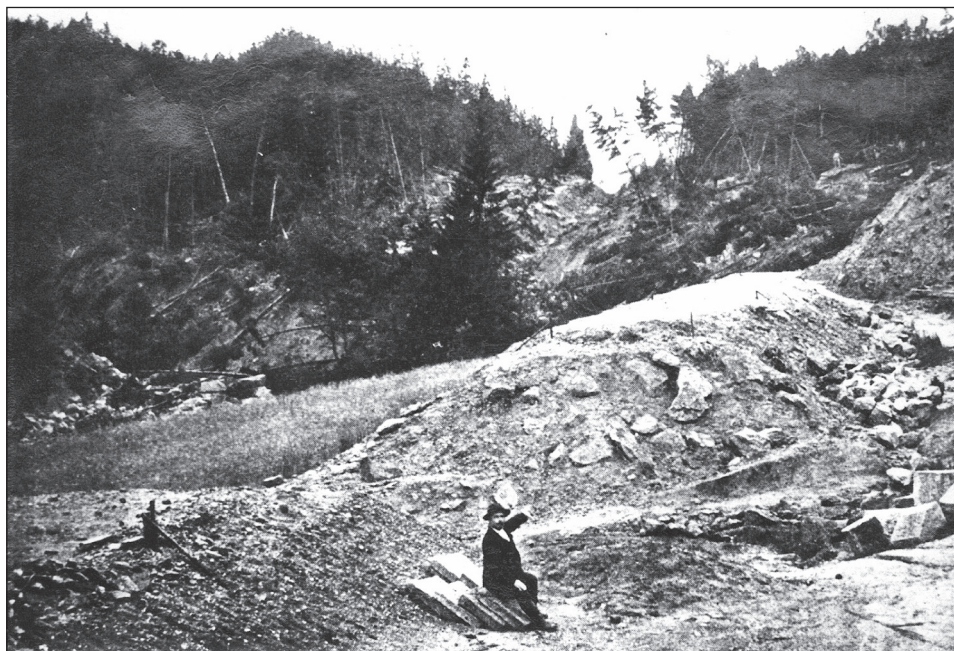
Fig. 5 – The bank of railway-track after the landslide in May 1872. Print from the *Geografie (Sborník ČSZ)* 28, Praha 1912. Photo by C. Purkyně.

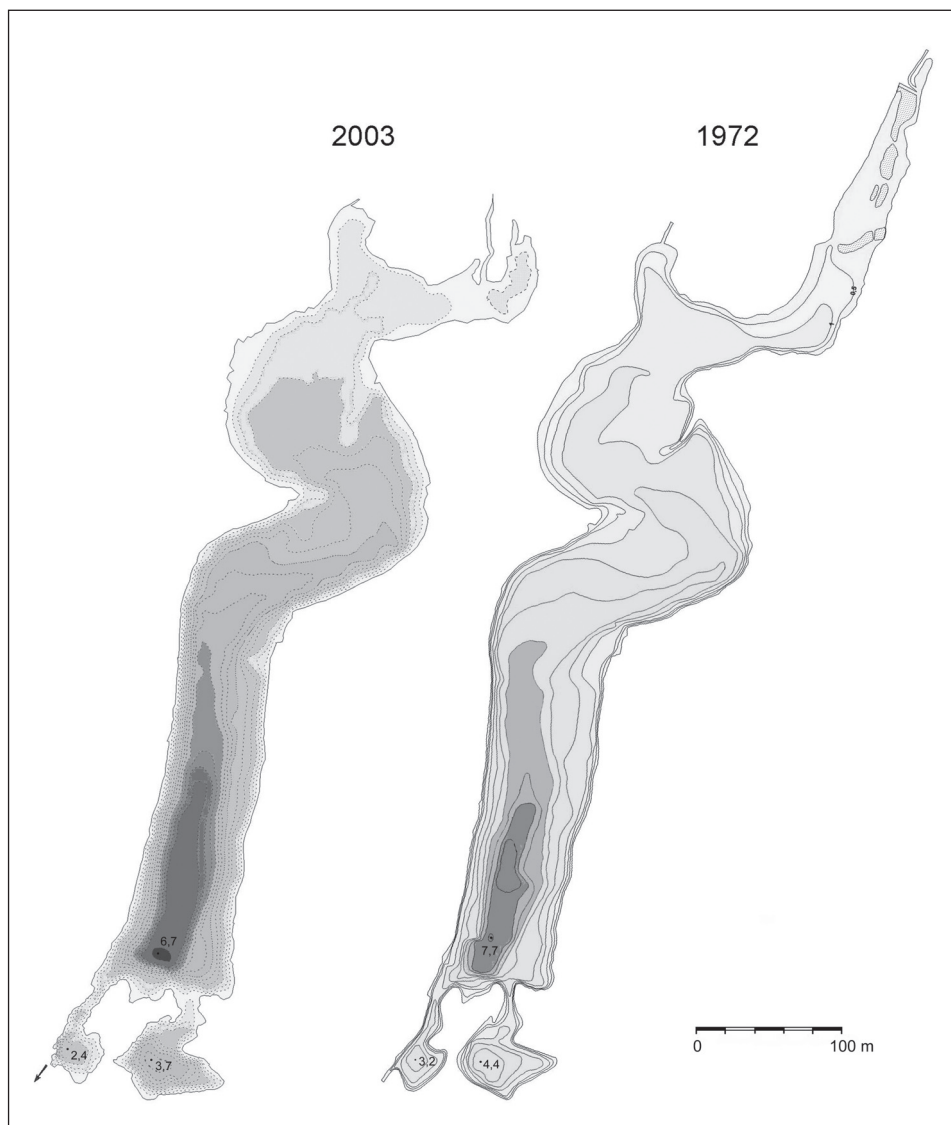
Fig. 6 – The bathymetric maps of the Mladotice Lake from measurements in 1972 and 2003

Geodetic and bathymetric measurements of the Mladotice Lake were made in 1972, 1990 (Janský 1976, 1977; Janský, Urbanová 1994) and 2003 (Česák, Šobr 2005). By comparing the results of these measurements it is possible to analyse the dynamics of the lake’s sedimentation in the past and to attempt to predict the further development of the lake basin, in other words to determine a period, after which the lake will be entirely filled with sediment (see maps in Fig. 6).

From the comparative analysis of bathymetric measurements from 1972 and 2003, the following results were gathered (Janský 2003): The maximum depth of the lake decreased from 7.7 m to 6.7 m. The 7 m depth level entirely disappeared and the area of all other depth levels decreased – the 6 m depth level decreased to 61% of its initial area from 1972, the 5 m level to 43%, the 4 m level to 60% (see Table 1). The decline in the area of shallow water levels was somewhat less dramatic – the 3 m level decreased

to 72% of its 1972 area, while the 2 m and 1 m levels decreased to 69% and 76%, respectively. A decrease in water level's surface area was measured, i.e. from an initial 5.8562 ha (1972) to 4.7364 ha (2003). This means a decrease of 1.1198 ha in the lake's surface area, i.e. 19% of its initial area in 1972. Maximum water level fluctuation between 1972 and 2009 was registered around 55 cm. Moreover, the automatic water-gauge station has measured the fluctuation of 26 cm in the last 12 months. After eliciting the bathymetric curves, the volume of the lake basin was calculated. From an initial volume of 141,380 m³ (1972) it decreased to 103,910 m³, i.e. by 37,471 m³. Therefore, the lake basin volume decreased by 26.5%.

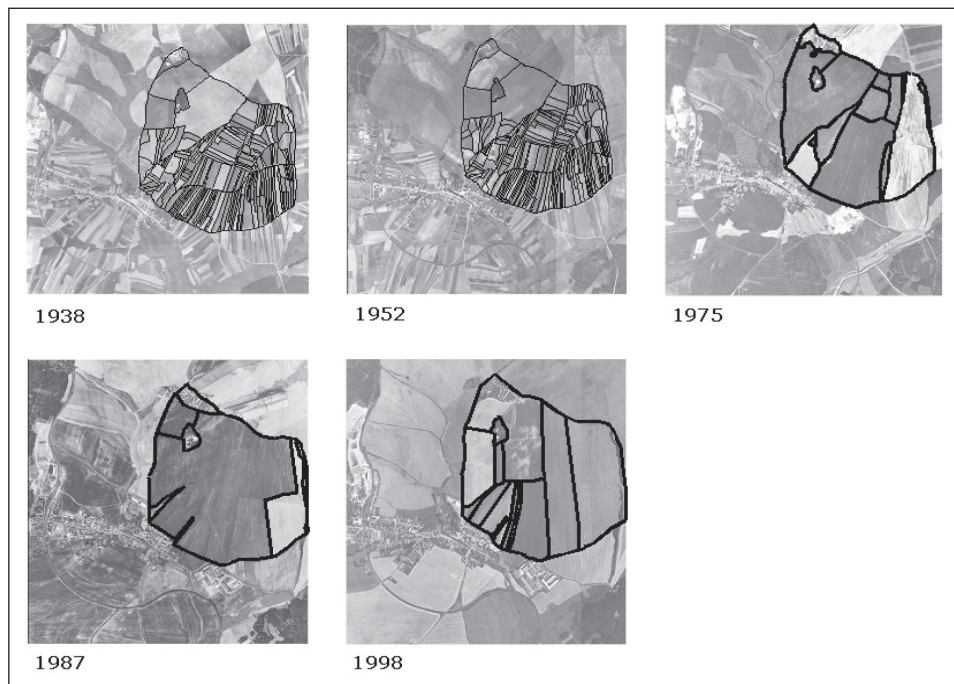
Fig. 7 – Air photos of a field about 1 km² in size, northeast of the town of Žihle in the catchment area of the Mladotice Lake. Collective farming had the greatest impact in land use changes between 1952 and 1975. Photographs: Military Topographic Institute Dobruška.

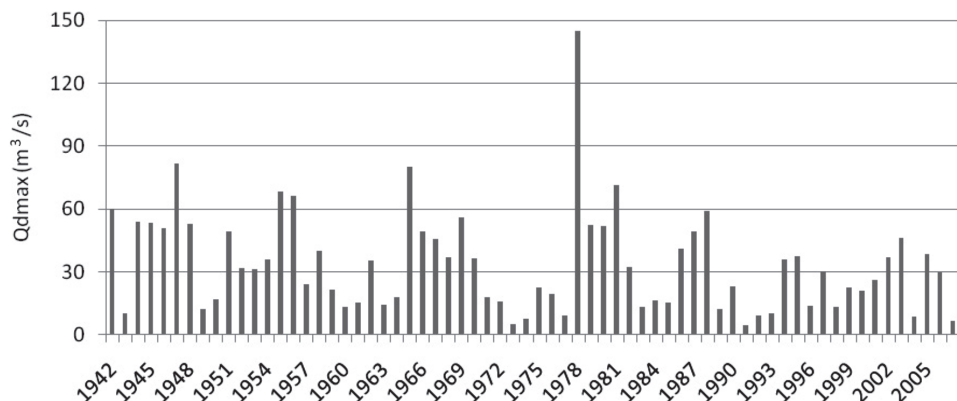
Fig. 8 – Maximum daily discharges in the Plasy (Střela River) station, the period of 1942–2007. Axis x – years. Sources: Czech Hydrometeorological Institute, Čurík 2009.

Runoff data serve to indicate the dimensions of past flood events. The nearest water-gauge station is located on the Střela River (Plasy station, 775 km²), which also drains the Mladotický stream. Daily records at this gauge date back to 1941. It is assumed that large floods recorded at the Střela River were also experienced at the Mladotický stream and that sediments were deposited in the lake during these events (Fig. 8).

To clarify whether the system changes are due to natural or anthropogenic causes, we analysed the time series of discharges at the Střela gauge at Plasy (775 km²), recorded since 1941. Figure 8 shows maximum daily discharges.

The flood events data of more than 20 m³/s (one-year flood) give a frequency of 34 floods within 30 years (1941–1970, with several events in one year) which decreases to a frequency of 25 events in following 30 years (1978–2007). Furthermore, the analyses show that the magnitude of the peak discharge has been decreasing as well, especially over the past 30 years. The average long-term discharge (1941–2007) at the Střela gauge station at Plasy is 2.896 m³/s. The peak discharge from 9 May 1978, i.e. 145 m³/s, was classified as a thirty-year flood.

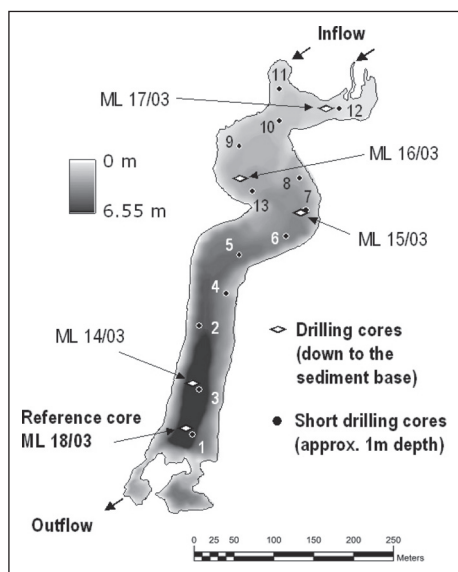
Fig. 9 – Map of the Mladotice Lake showing locations of short and long cores. The core ML 18/03 is located near the outflow with the maximum water depth.

In spite of this setback, we obtained information about the distribution of the sediments by extracting 13 short cores of about 1 m in length. Five long cores were drilled down to the bottom of the sediments. The reference core ML 18/03 was extracted from the deepest part of the lake and core ML 14/03 was investigated for diatom analyses. Core sites are shown in Figure 9.

The lake sediments of reference core ML 18/03 (Fig. 9) are largely muddy silts. The particle-size distribution in Figure 10 shows two noteworthy features: (1) Sand is found only in the lower sediment sequences. This is also the case in the other sediment cores and suggests that the sand was brought in by the Mladotický stream. During the early decades there may have been some additional sediment input from the mass failure area, which was without any vegetation during the first few years. (2) The particle-size median shows a distinct change in sedimentation at about 190 cm. Below this depth the sediment is coarser and the range fluctuates fairly widely; above it, the median remains constant at about 4 µm (Fig. 10).

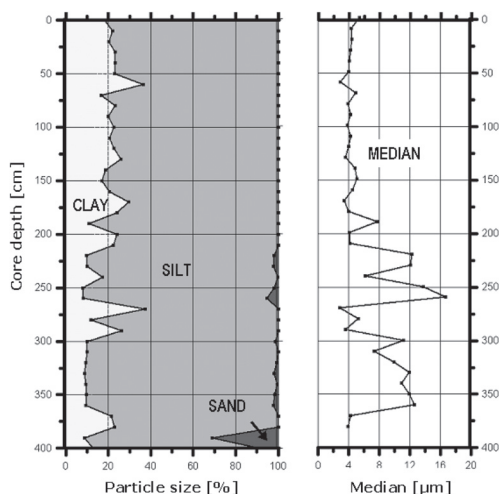
Fig. 10 – Particle size distribution of sediment core ML 18/03 (core depth 0–400 cm)

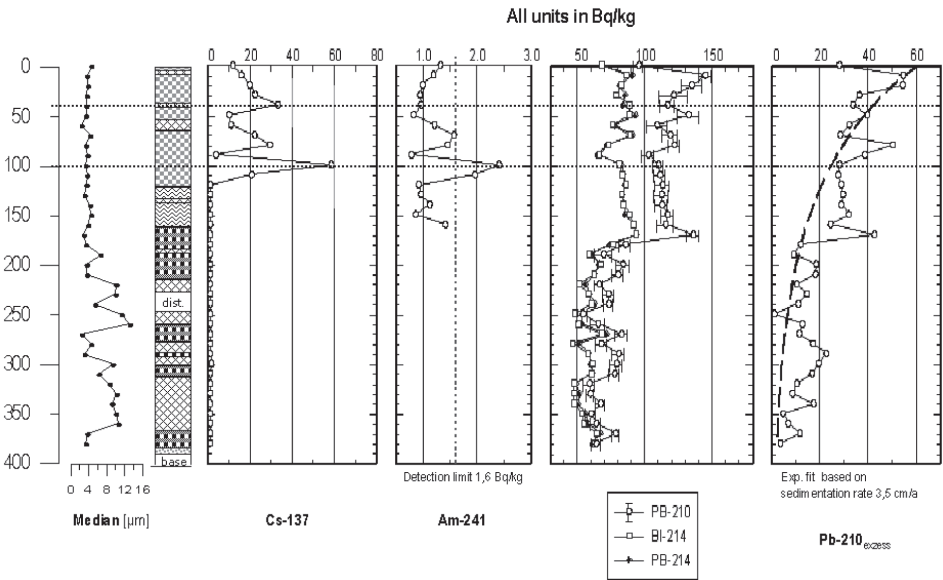
Fig. 11 – Isotope contents in reference core ML 18/03 (^{137}Cs , ^{241}Am , ^{210}Pb)

The absolute chronology of the sediments is also based on available ¹³⁷Cs, ²⁴¹Am and ²¹⁰Pb measurements (Fig. 11). The radiation of ¹³⁷Cs and ²⁴¹Am maxi-

mum at a core depth of 100 cm is attributed to the 1963 maximum of bomb fallout which started in 1954. Americium clearly demonstrates bomb fallout because there was no emission of americium during the Chernobyl disaster. The peak at 40 cm core depth is assigned to the Chernobyl fallout in 1986.
