MICHAL BÍL, OLDŘICH KREJČÍ, MARTINA BÍLOVÁ, JAN KUBEČEK,
JIŘÍ SEDONÍK, VLADIMÍRA KREJČÍ

A CHRONOLOGY OF LANDSLIDING AND ITS IMPACTS ON THE VILLAGE OF HELENKOVICE, OUTER WESTERN CARPATHIANS

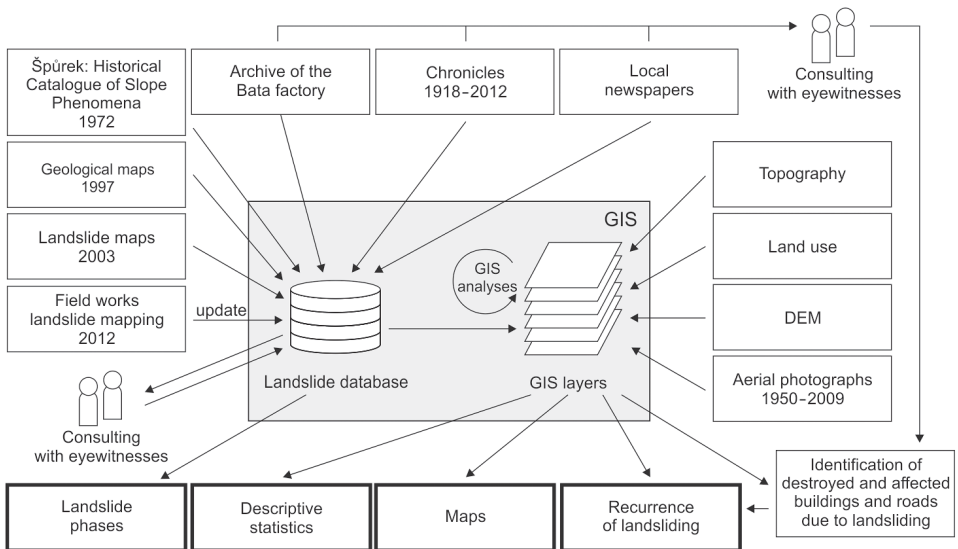
Fig. 2 – Workflow indicating how the database of landslides, list of affected roads and buildings by landslides and landslide phases originated.

The area of Halenkovice, particularly “Na Díle” landslide (see section 4.2), has been systematically monitored since 1999 and ranks among the most investigated landslide areas within entire Czechia. The statistics and GIS spatial analyses were carried out in the ArcGIS 10.2 (Fig. 2).

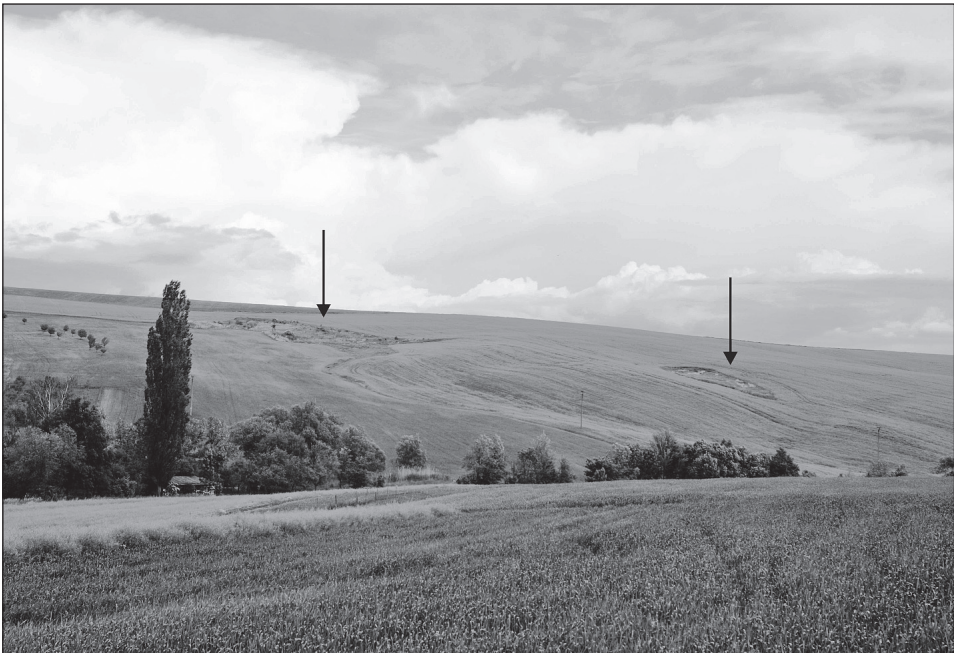
Fig. 3 – An example of slopes affected by the existence of dormant landslides. The arrows delimit two 2010 landslides. Photo: Oldřich Krejčí.

Altitudes within the Halenkovice cadaster descend from the north-east (maximum height 410 m) to the south-west (minimum height at the Vrbka floodplain 204 m). The erosion-denudational relief has the character of hilly land from the morphometric point of view. The erosional processes take the form of river erosion, piping (Bíl, Kubeček 2012) and landsliding (Krejčí et al. 2002b). The morphology of the slopes is heavily influenced by the existence of both dormant and active landslides and is therefore both uneven and undulating (Fig. 3).

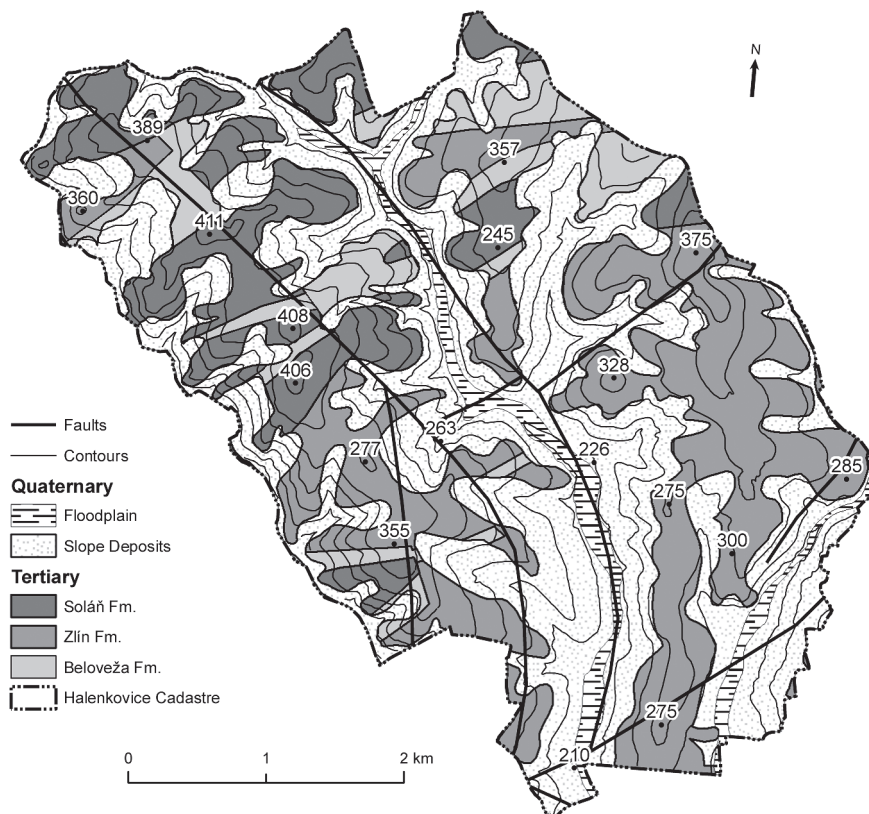
Fig. 4 – Geological setting of the Halenkovice cadastral area. The Quaternary cover shows places which are particularly susceptible to landsliding. Source: Czech Geological Survey.

The Carpathian Flysch Belt is represented by the Magura Group of thrust sheets (Hroudá et al. 2009), which consists here of the Rača Unit only (Fig. 4). The flysch sediments of this unit are distinguished in particular by their lithological evolution into the lithostratigraphic members. The oldest one is the Soláň Formation (Fm.). It is represented here by the Lukov Member: thick rhythmical flysch sediments dominated by sandstones, in places with conglomerates, over claystones. The Lukov Member is deeply weathered up to a depth of 10 m and produces unstable sandy colluvium on the slopes. Beloveža Fm. is characterized by rhythmic flysch rocks with non-calcareous claystones and quartz fine-grained sandstones, mostly thin bedded. In certain places Beloveža Fm. contains up to several tens of meters of thick coarse-grained arkose sandstones, which may

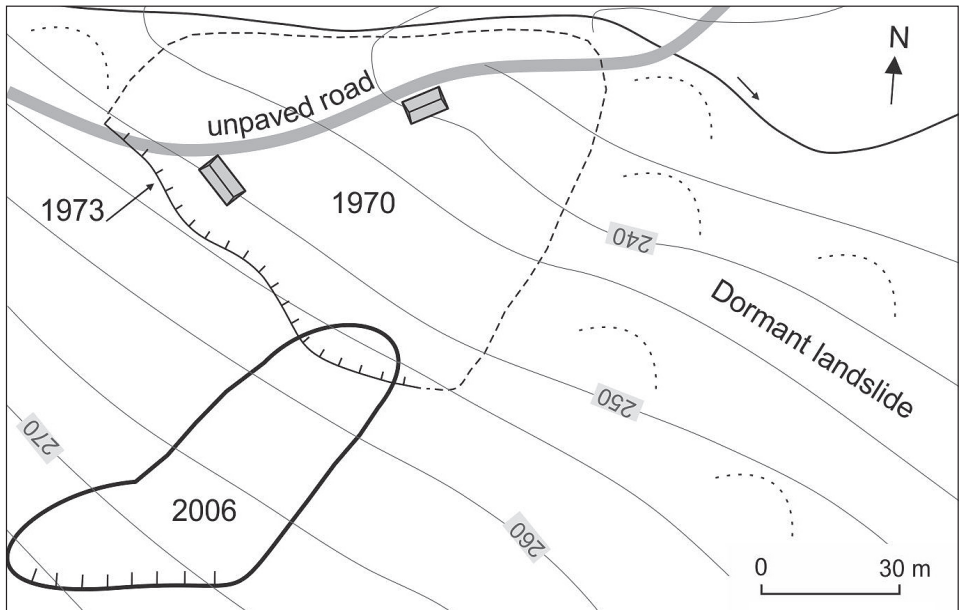
Fig. 7 – A sketch of the “Lipové” landslide. Two residential houses remained on the dormant landslide up until 1970. The extent of the 1970 landslide, particularly the main scarp, can be delimited from the 1973 aerial photo. The approximated border of the 1970 landslide is marked by a dashed line. The uppermost part of the older landslide was activated once again in 2006. Source: aerial photos, MGHO.

The “Lipové” landslide: As a result of rapid snow melting accompanied by rainfall in April 2006 another landslide calamity took place. It primarily affected the area of the southern part of the flysch zone in Moravia (Bíl, Müller 2008). Among the 6 landslides in Halenkovice one was also called “Lipové” (Fig. 5, letter D and Fig. 7). From an interview with eyewitnesses we realized that up until 1970 there were residential houses close to the active landslide. The 2006 event affected the slope in close proximity to the 1970 landslide.

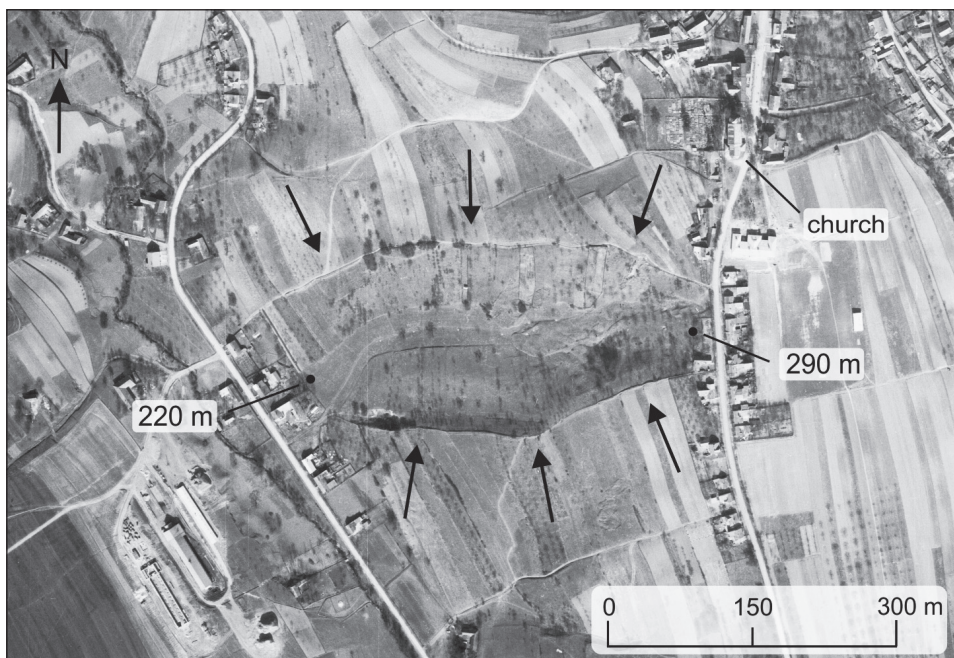
Fig. 8 – A dormant landslide whose accumulation was washed away. The arrows show the border of the slope deformation. Source: aerial photo from March 1961, MGHO.

Another marker for the presence of a dormant landslide, particularly a deep-seated one, is morphological, that is the missing mass of a slope. A distinct shape which can be easily identified on old maps and aerial photos as a dormant landslide is in the exact middle of the village, with particularly its main scarp still being clearly pronounced (Fig. 5, letter B and Fig. 8).

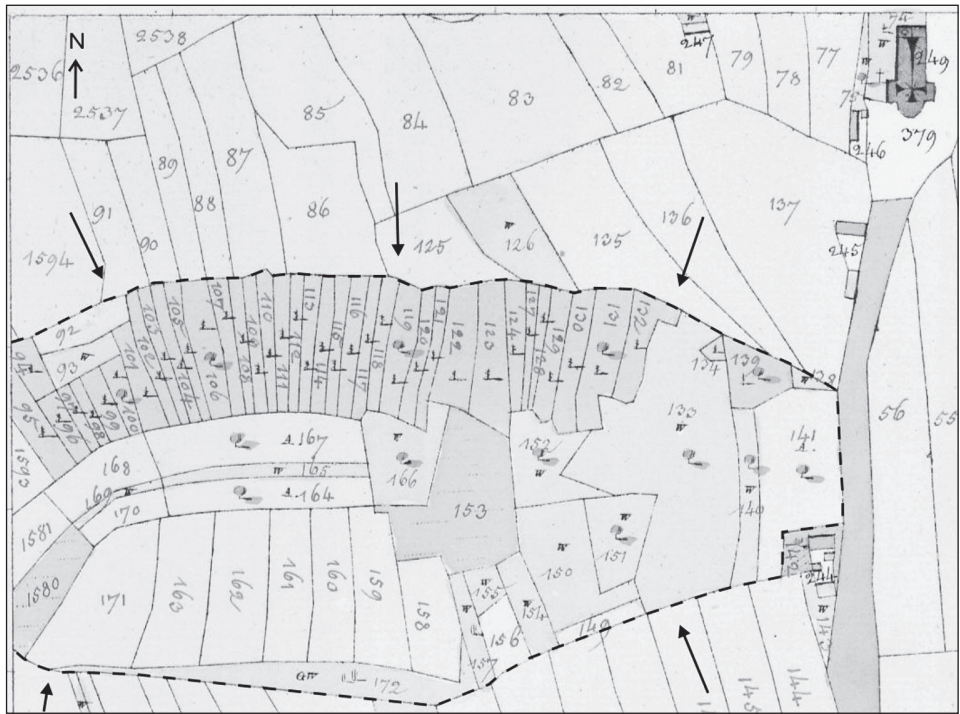
Fig. 9 – Map No. 0663-1-009 of the Stable Cadaster. The dormant landslide, see also Figure 8, can be easily delimited from the shape and the arrangement of the parcels and from the different land use. Source: Archive of the Czech Office for Surveying, Mapping and Cadaster.

This landslide was also depicted on a map from the Stable Cadaster which was mapped in the middle of the 19th century. The shape of the main scarp can be seen on the map (Fig. 9) which is also pronounced by a different land-use, where the slopes with the southern aspect were used as orchards and vineyards. The first written references to the village of Halenkovice date back to 1634 (Kašíková 2004). We could speculate that this landslide, lying at the exact middle of the village, originated long before the first settler of the modern era arrived here.

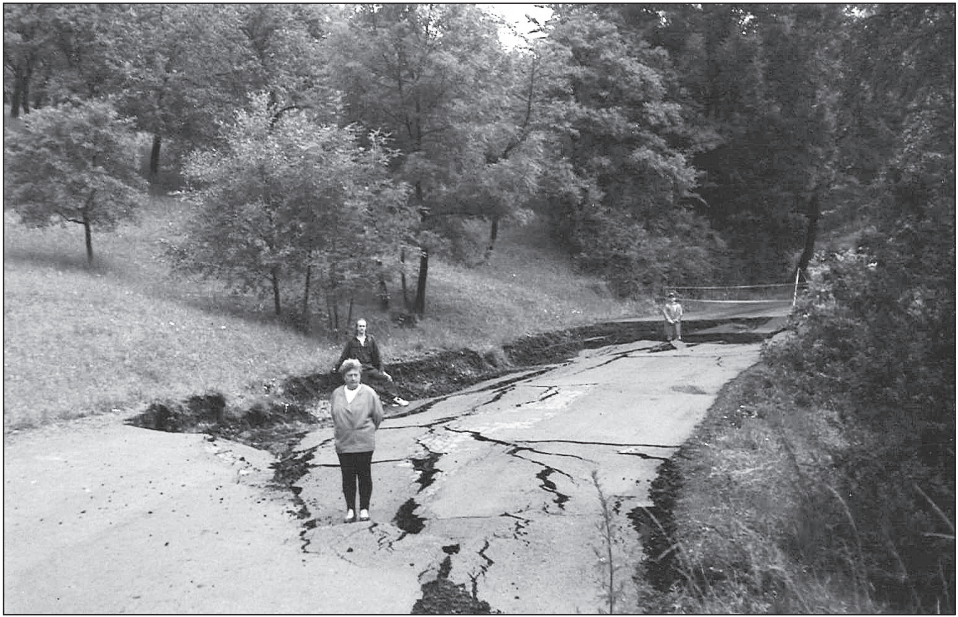
Fig. 10 – Example of damage to a road by a landslide in the village of Halenkovice in July 1997 when the road embankment subsided by 1 m. Photo A. Horká.
